This final report presents the results of field monitoring and describes remedial measures to improve stability through the spring of 1980.

REPORT NO. FHWA/CA/TL - 80/27

LONG-TERM PERFORMANCE OF THE FIRST REINFORCED EARTH WALL IN CALIFORNIA

**FINAL REPORT
AUG, 1980**

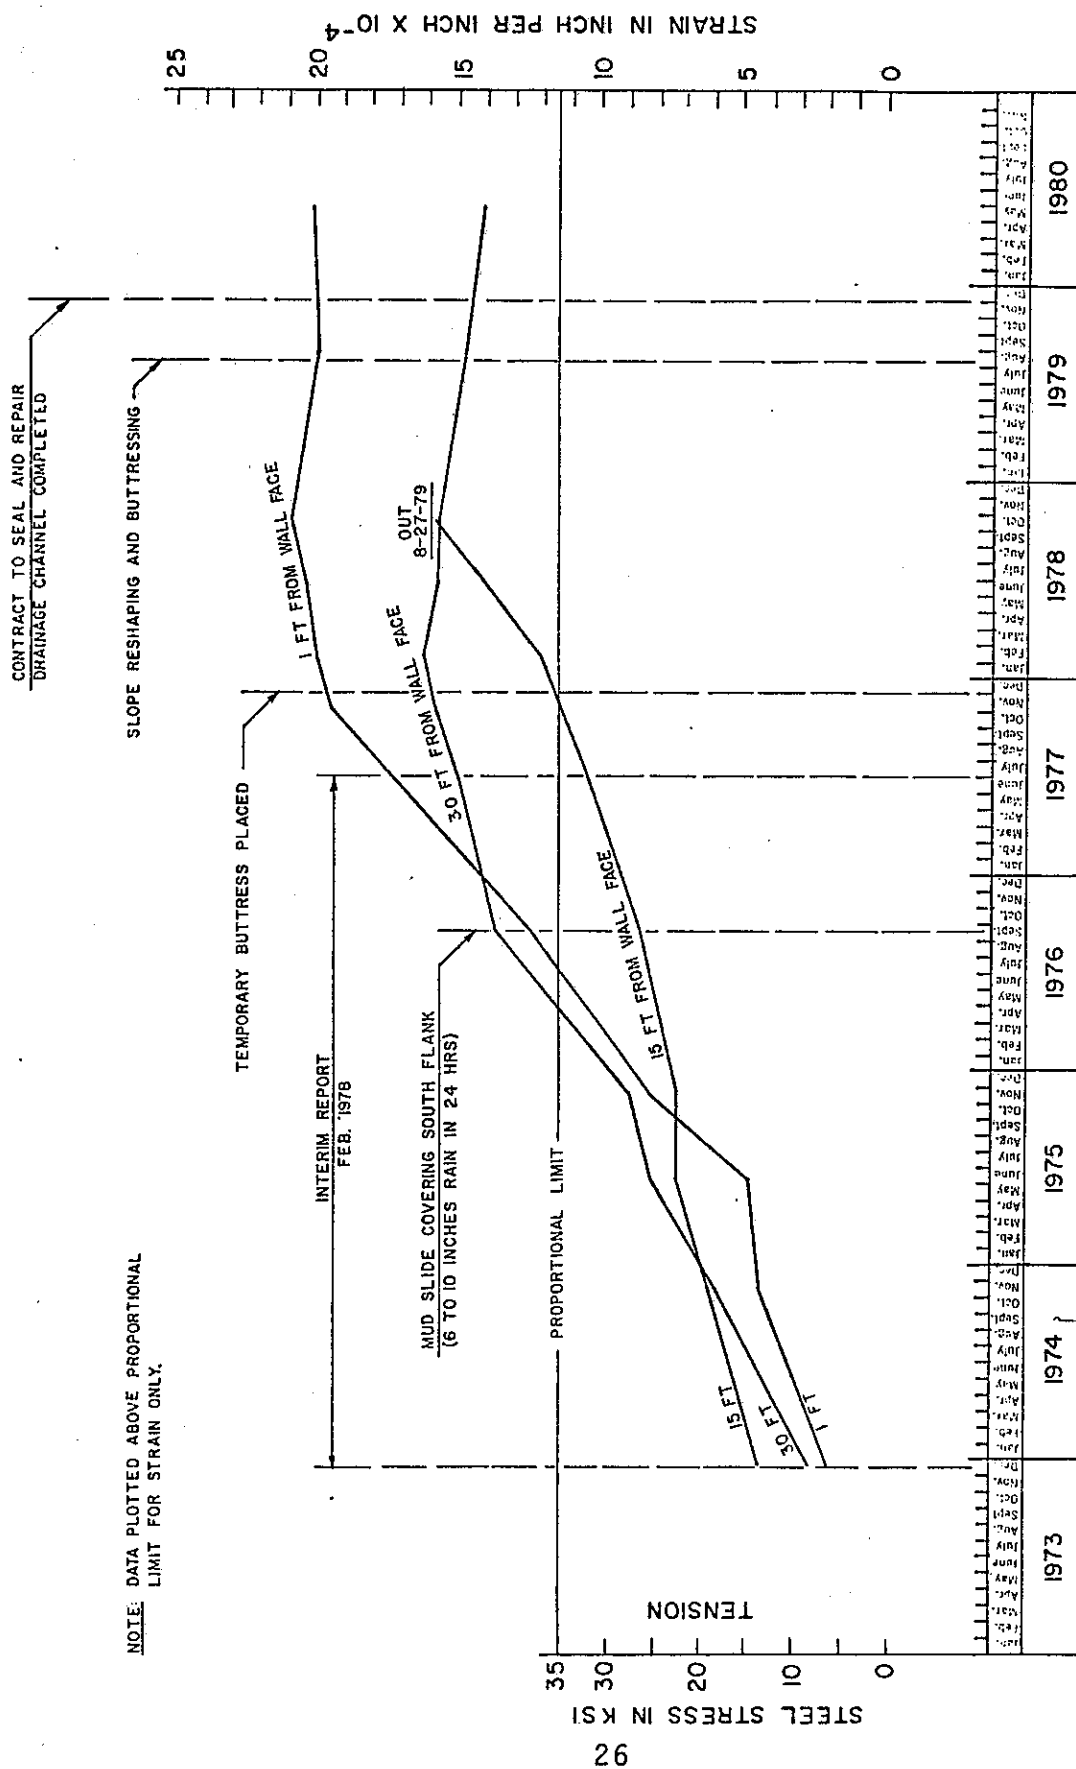
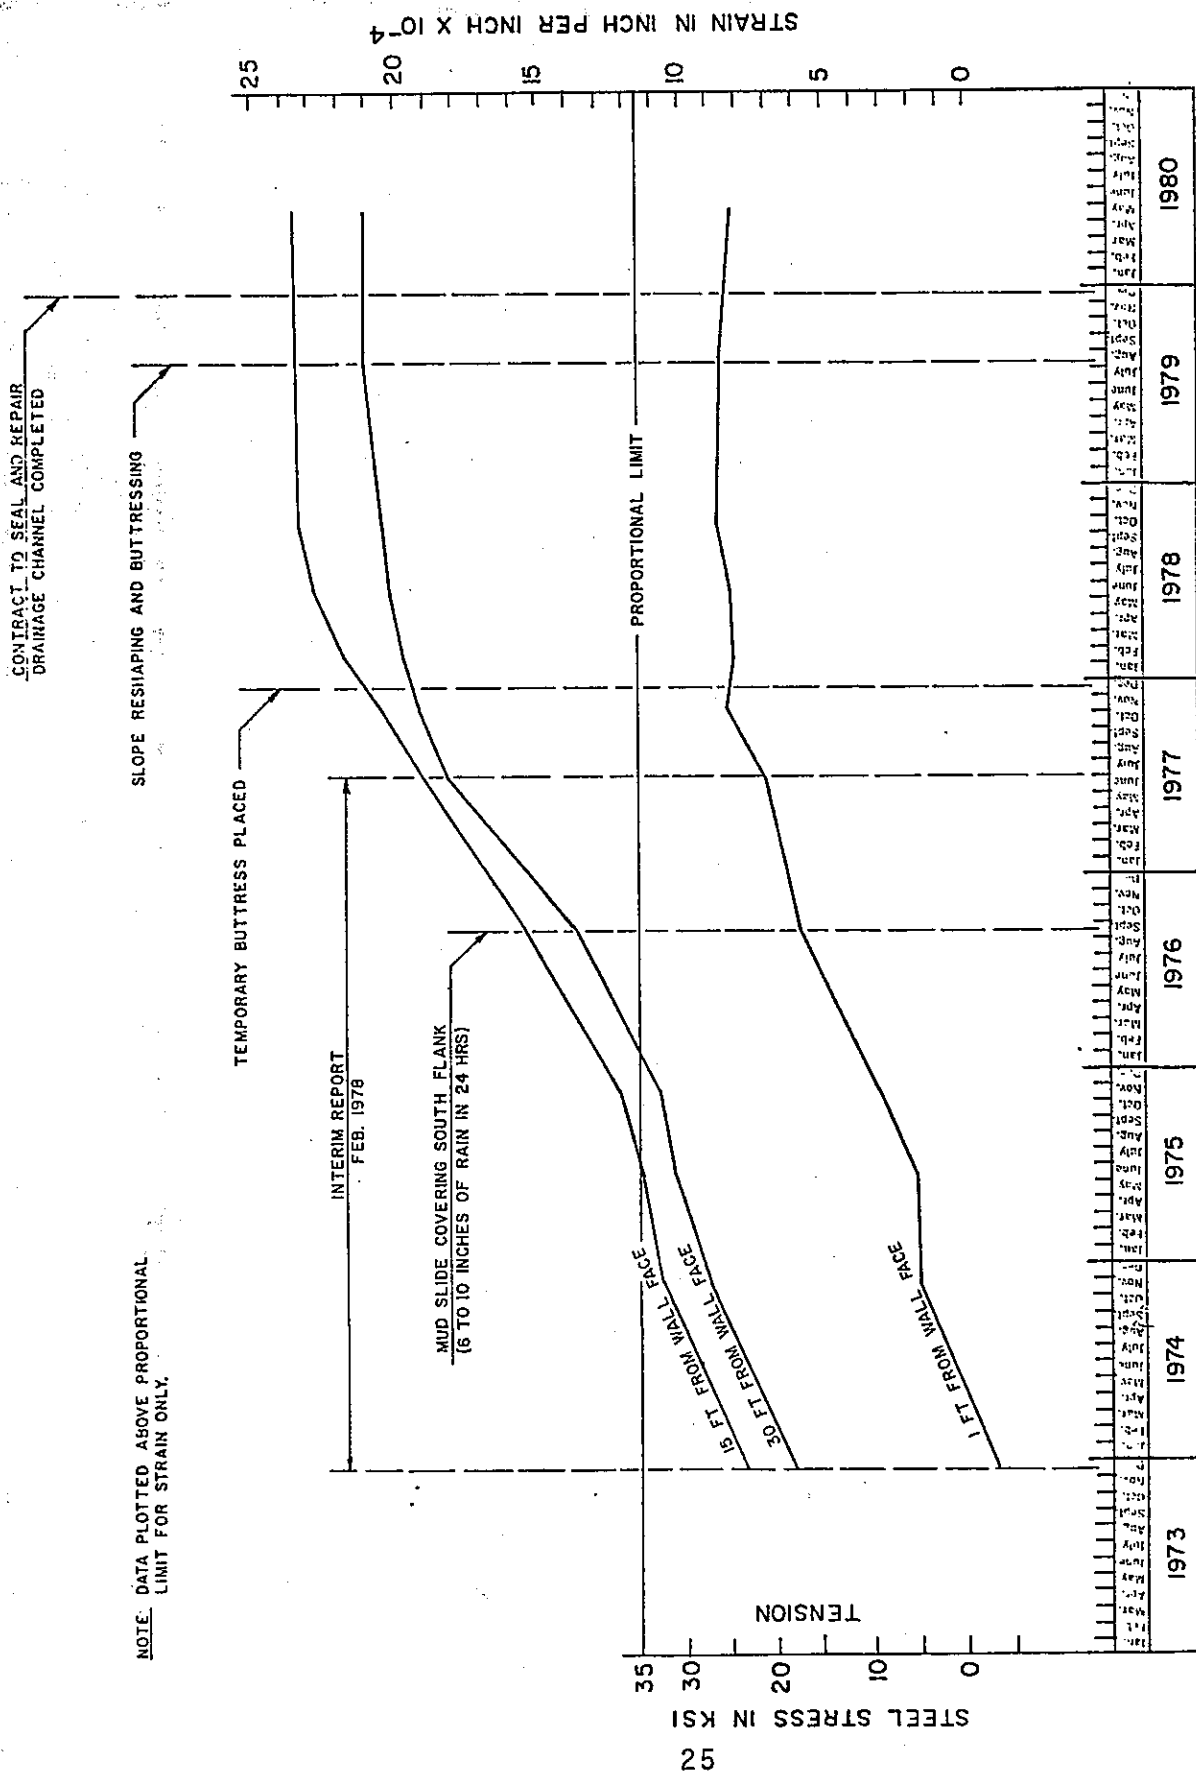
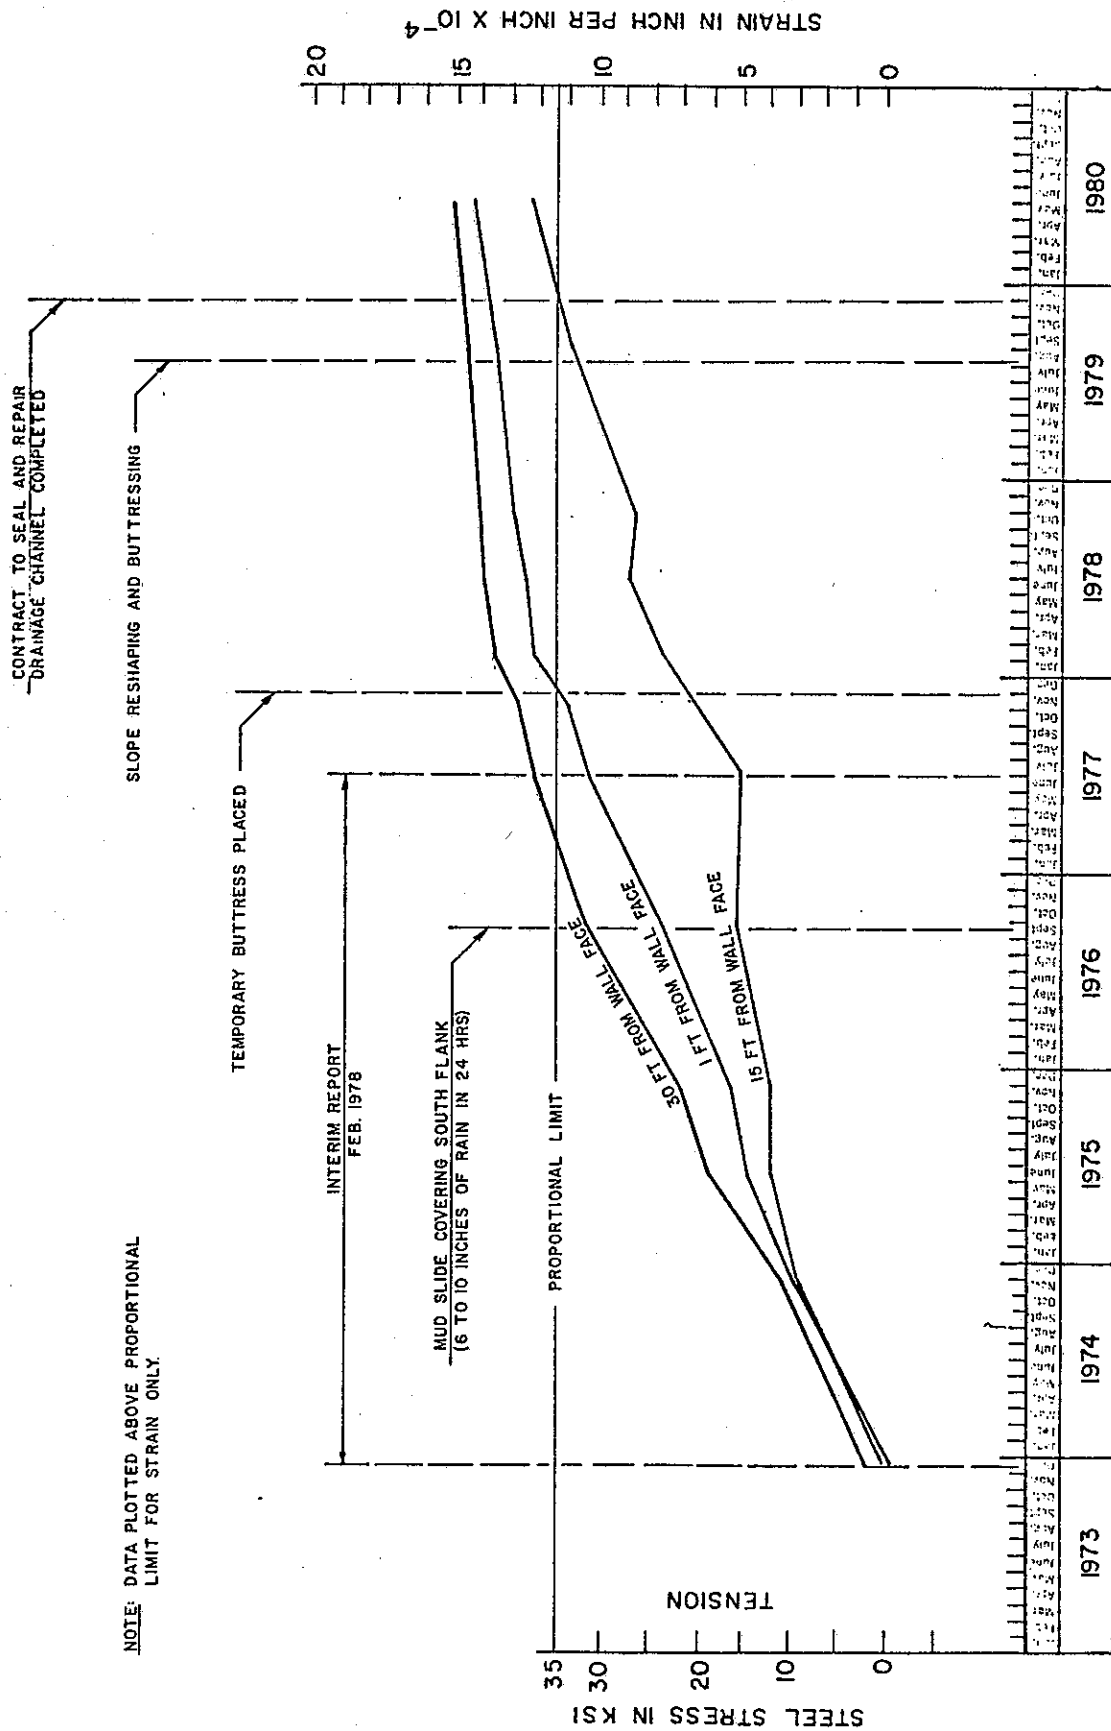
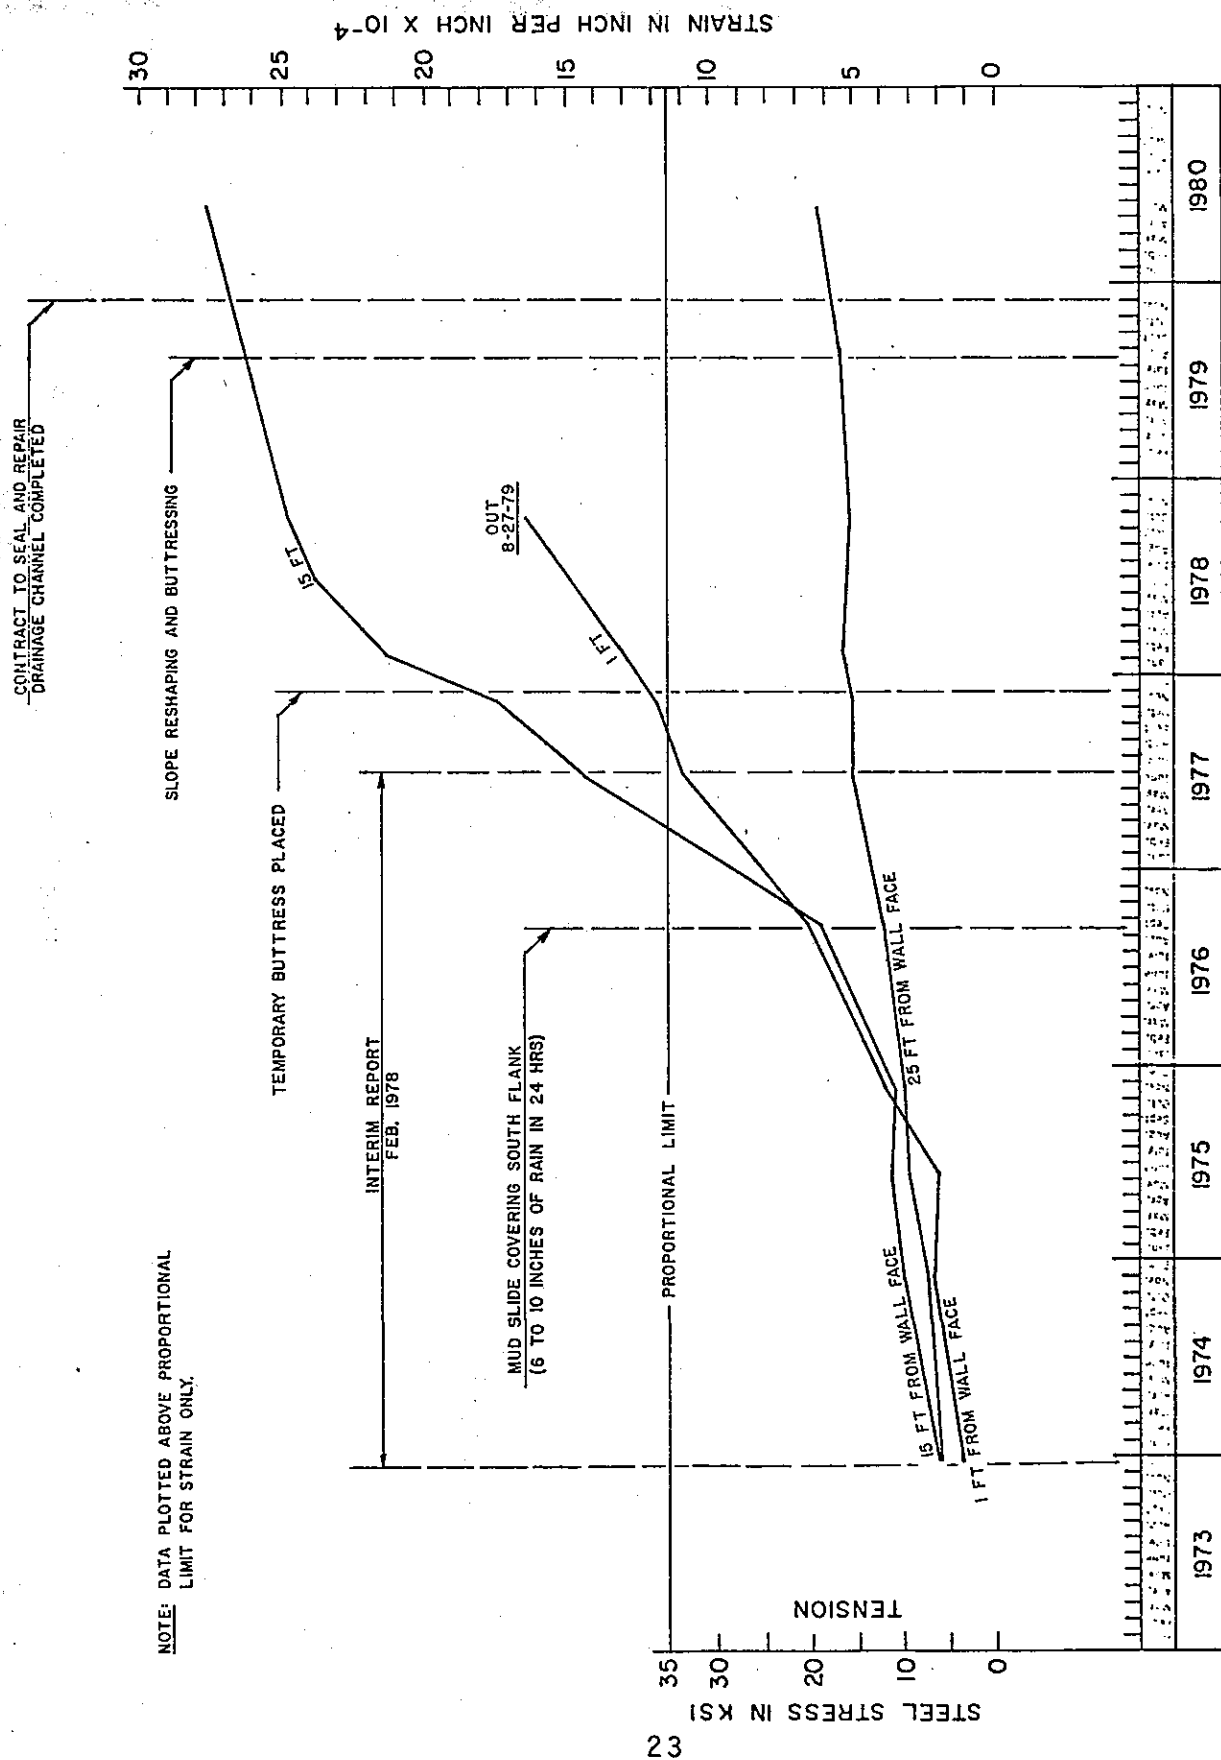
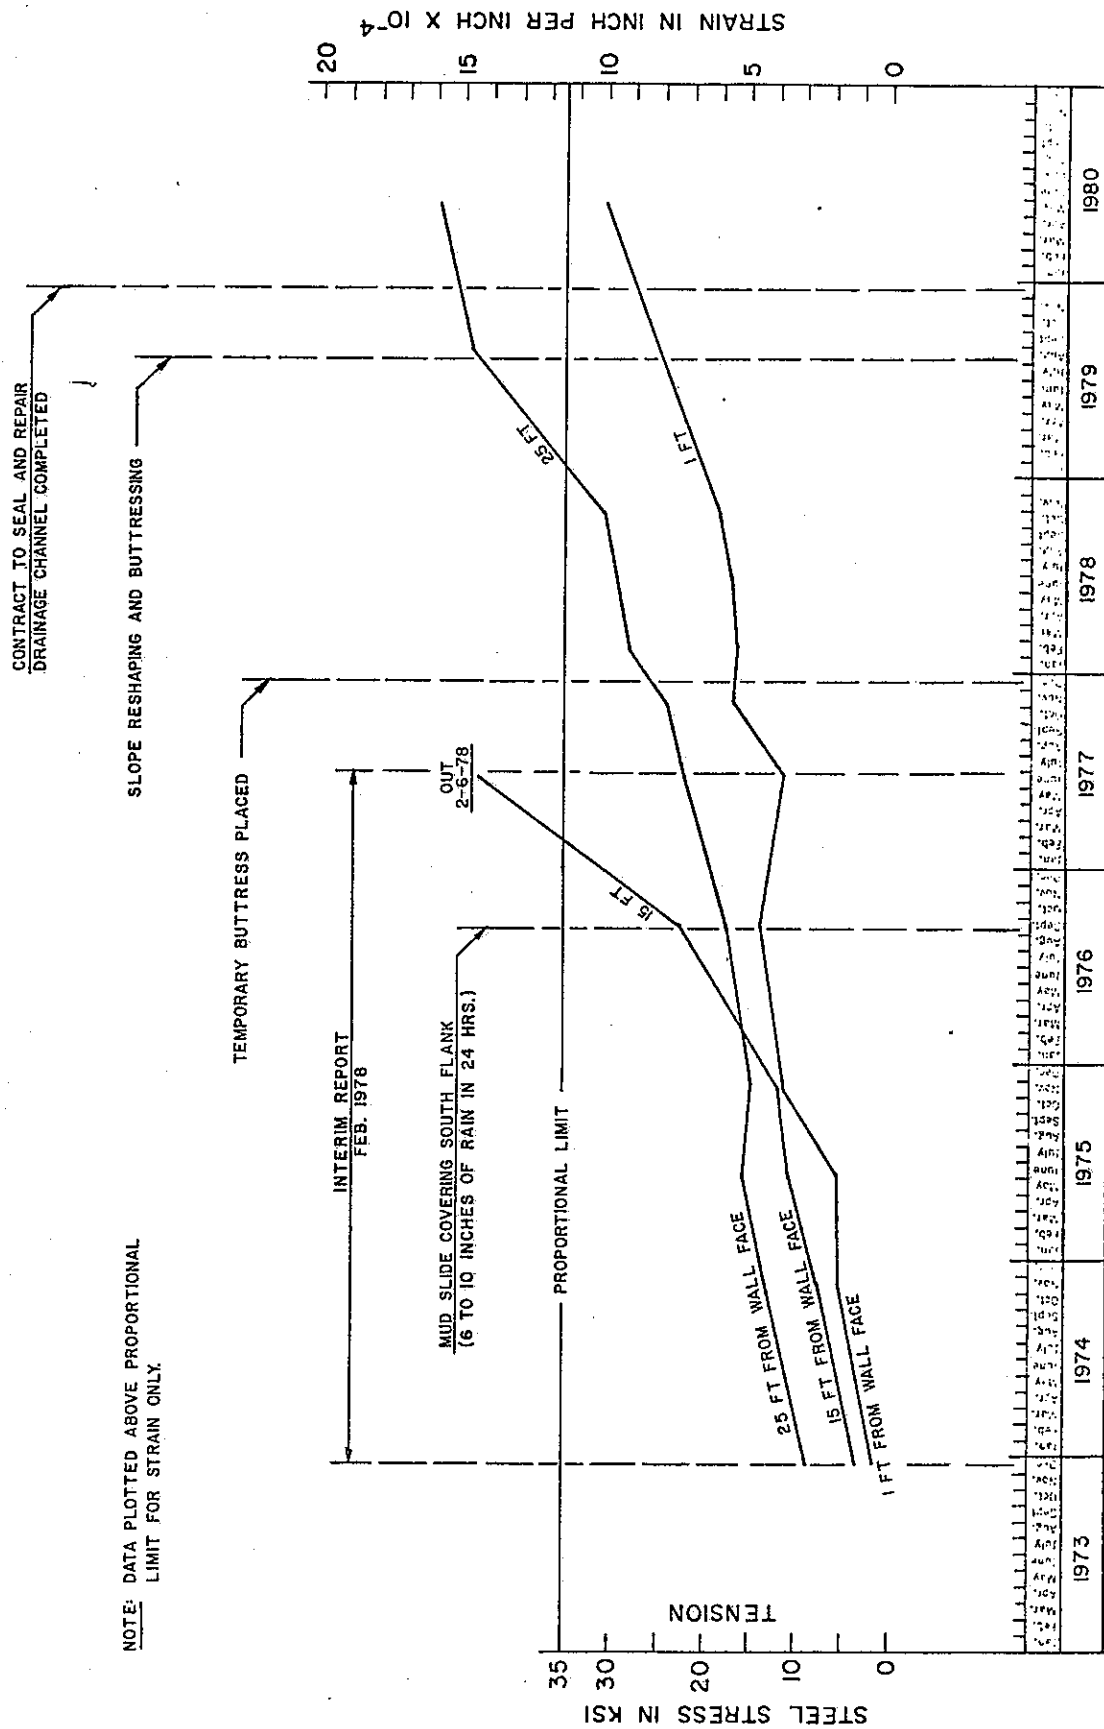
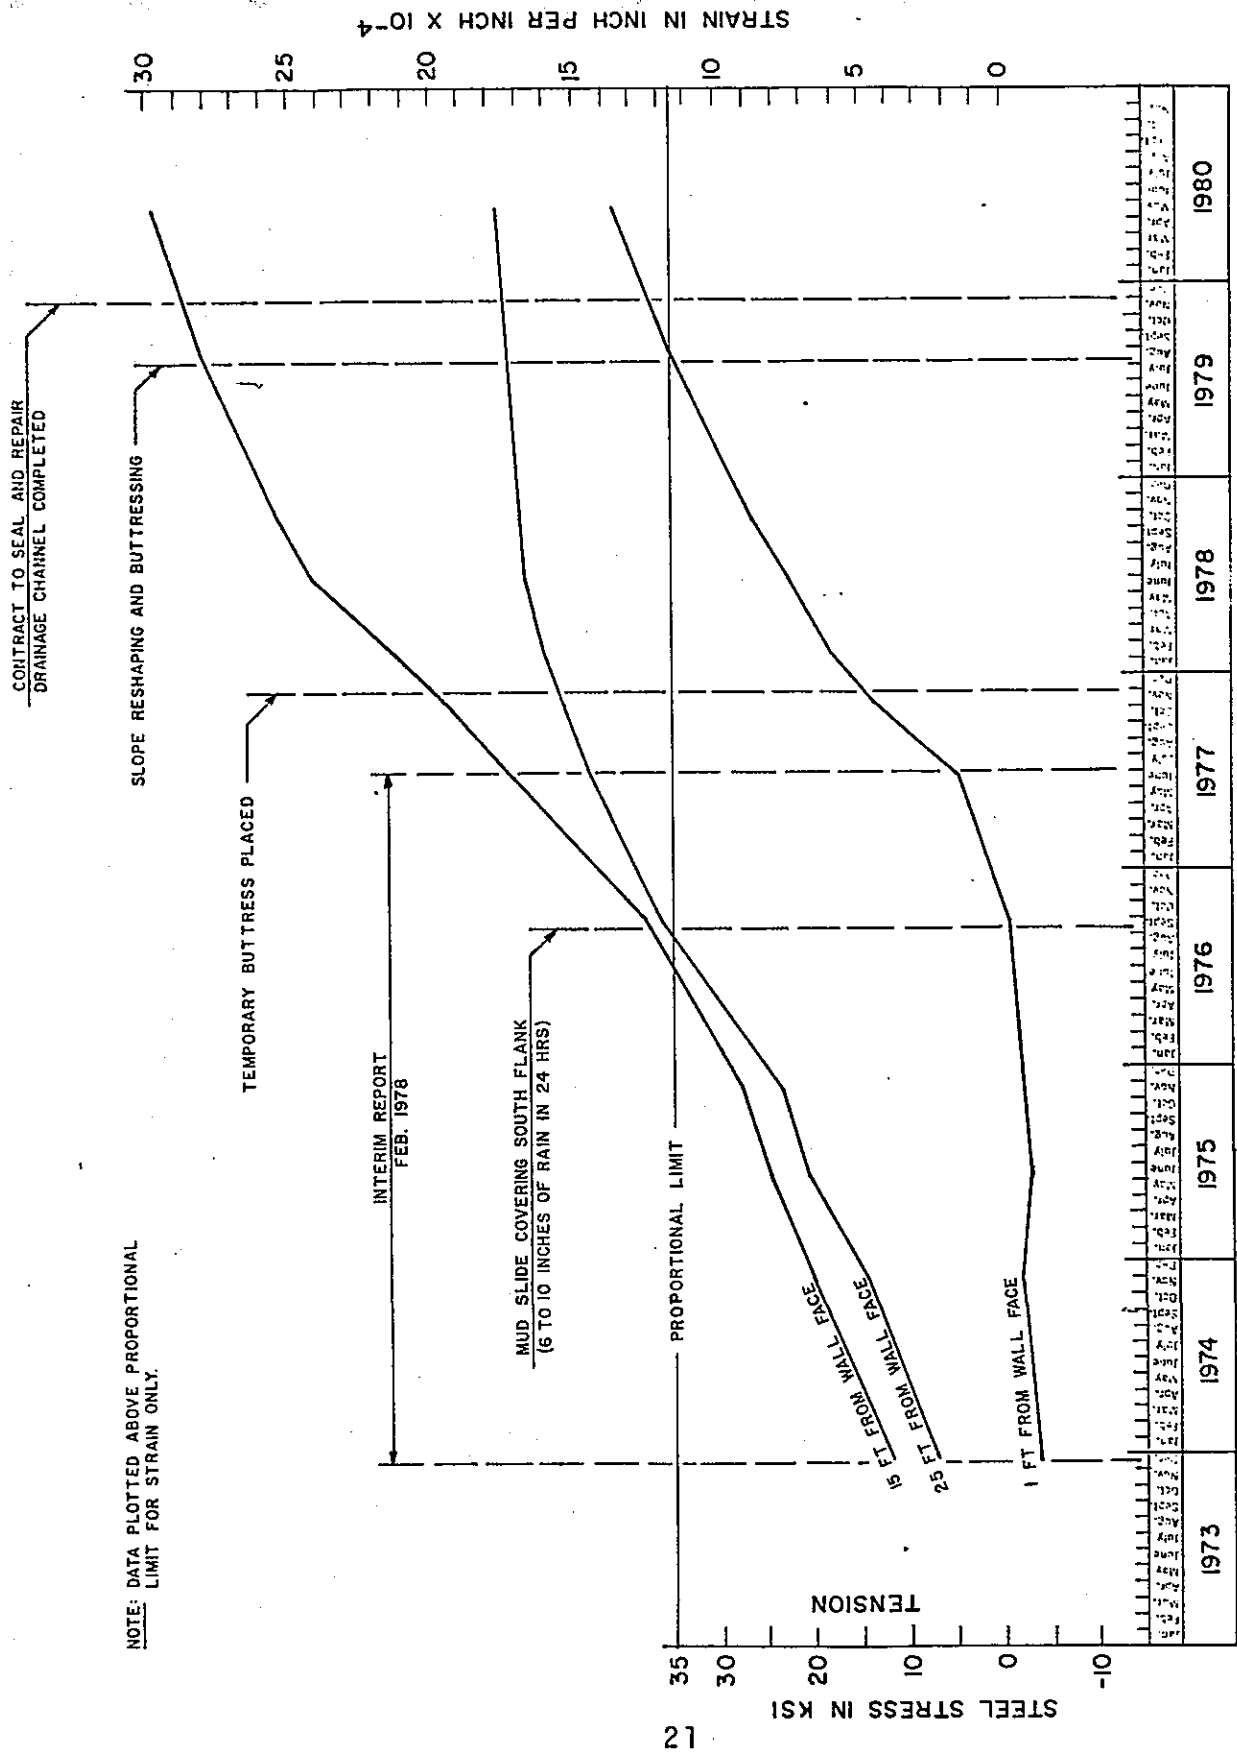
Strain gage measurements obtained on the reinforcing strips have shown continuous increases since the last reported readings in June 1977. However, some significant decreases in strain rates have occurred since placement of the temporary buttress in December 1977 and also after completion of the correctional work during the fall and winter of 1979. (Refer to Figures 2 through 7 and Tables 1 through 4.)

of the above work. These measurements indicated that while the strains on some of the reinforcing strips had stabilized, others had increased since the last measurements in October 1978. (Refer to Figures 2 through 7.)

The strain gage data observed on June 28, 1978, indicated that the stresses in the steel strips embedded in the center chord and the south flank were continuing to increase (Figures 2 through 7). However, the increases in steel stresses in the south flank were more significant than those in the center chord of the wall. These continual increases in steel stresses along with newly discovered cracks on the pavement of the north flank indicated that the south flank was still moving outward.

Field data obtained from 1973 through 1976 indicated continuous increases in steel stresses in some cases exceeding the proportional limit of 35,000 pounds per square inch for the steel strips. (Refer to Figures 2 through 7.) The location of the various strain gages and other instruments are shown on Figure 8. Horizontal movements have continued at the top and bottom of the wall along the south flank. These movements have been recorded on the monuments shown on Figure 9 and are presented on Figures 10 and 11. The increases in steel stresses and horizontal movements may have been caused by additional earth pressure from the continuous deposit of debris from the slide behind the wall (Photo 3). Several other conditions not anticipated in the original design have also developed since construction. A mud slide in September 1976 deposited several feet of debris on the roadway subsequent to an intense 6 to 10 inch rain storm during a 24 hour period. A maximum settlement in excess of 4 feet has also been experienced since the beginning of construction which may have sheared drainage collector pipes on the back slope behind the wall. Seepage pressures may have also developed due
